Name Of Dam: STAUNTON DAM
Location: AUGUSTA COUNTY, VIRGINIA
Inventory Number: VA. NO. 01518

PHASE I INSPECTION REPORT

NATIONAL DAM SAFETY PROGRAM

SCHNABEL ENGINEERING ASSOCIATES, P.C./
J. K. TIMMONS AND ASSOCIATES, INC.

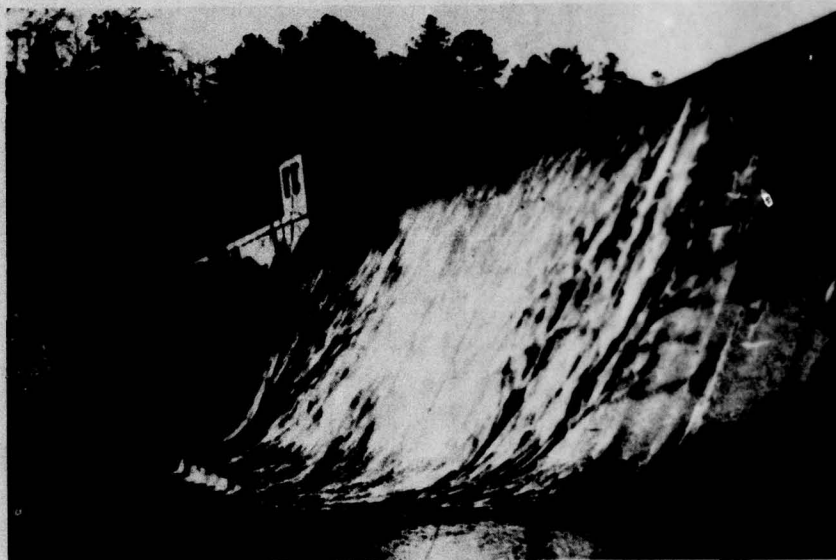
**VIEW OF WESTERN SECTION OF
DOWNSTREAM SIDE OF SPILLWAY
Photo #1**

1.6 Surface Cracks, Concrete Surfaces: Various surface cracks on spillway. Spillway was sealed with Gunitite in 1971, but appears to be bleeding lime from concrete. Observation by owner indicates no visible wet spots when water below spillway.

The gunited surfaces should be sounded and the expansion joints on spillway checked for leakage at a period of no flow over the spillway surface.

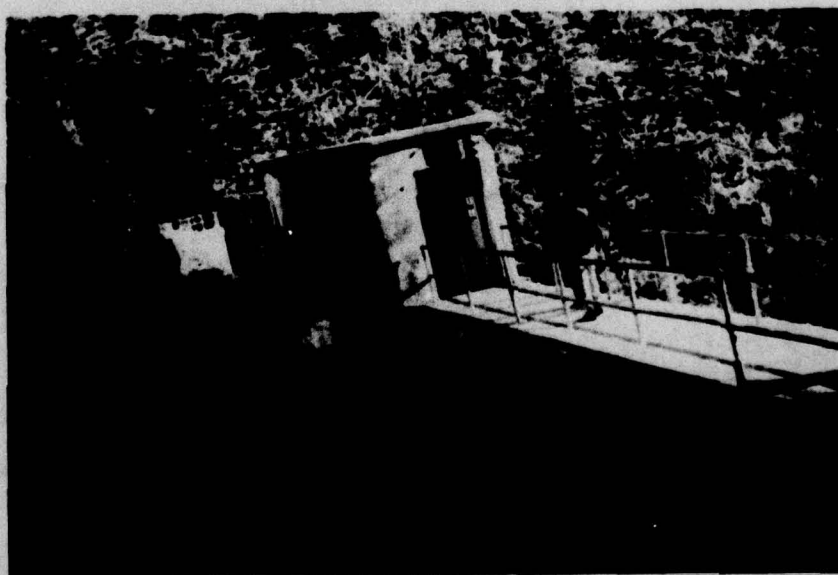
VIEW OF GATE HOUSE STRUCTURE
Photo #4

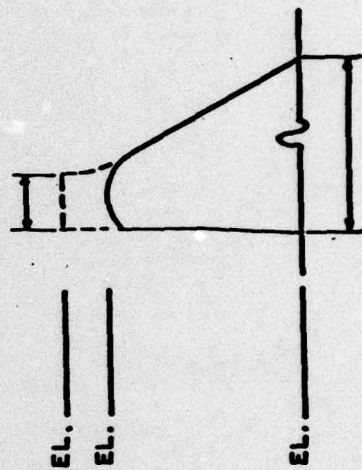
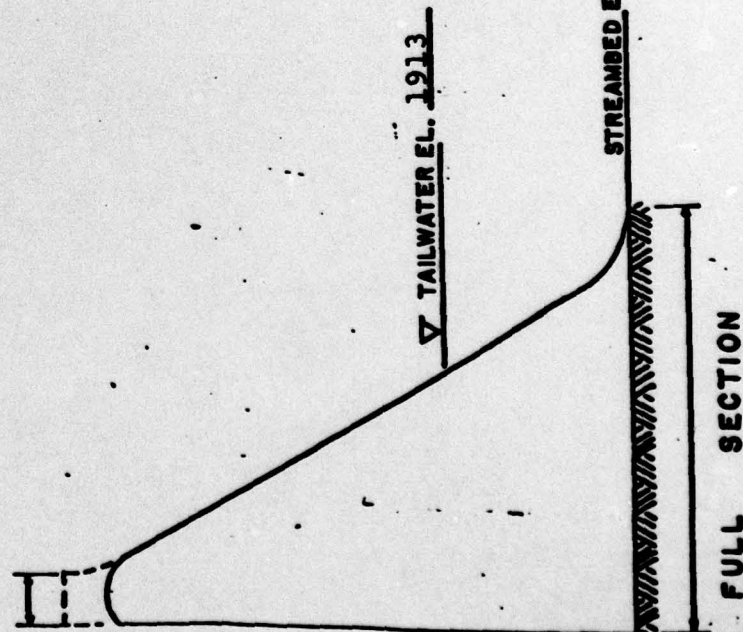
passes within the middle third of the base. Under surcharged conditions caused by the PMF, the resultant of all forces will cause overturning. Without direct evidence that the dam is keyed into the bedrock, and assuming only a surface of bedrock foundation, the dam would be subject to overturning failure under the PMF loading without regard to end restraint.

LOADING CASE	ELEV. HEAD WATER	ELEV. TAIL WATER	ΣV	ΣH	$\frac{\Sigma H}{\Sigma V}$	LOCATION RESULTANT FROM TOE	% BASE IN COMPRESSION	FACTOR SAFETY SLIDING	FOUNDATION PRESSURE	
									TOE	HEEL
NORMAL POOL	1919	1878.5	49.3 K	55.0 K	1.11	15.6'	100%	1.35	4.11ksf	0.84 ksf
PROBABLE MAXIMUM FLOOD	1933.5	1913	33.3 k	47.5 k	1.42	4.1'	31%	1.32	5.4 ksf	0 ksf

NOTE: ANALYSIS DOES NOT CONSIDER ABUTMENT END RESTRAINT.

7.3 Investigation by Owner: This investigation should include sufficient subsurface exploration to define the depth of embedment of the structure. The stability of the dam should then be assessed with respect to sliding and overturning utilizing the estimated foundation geometry and estimated strength of the foundation rock and friction resistance of the concrete-rock interface using the methods defined in Reference I, Appendix V.
